# Manhole Inspection Summary

Manhole # S43C\_\_004MH

Insp Date: **4/13/08 11:49 AM**

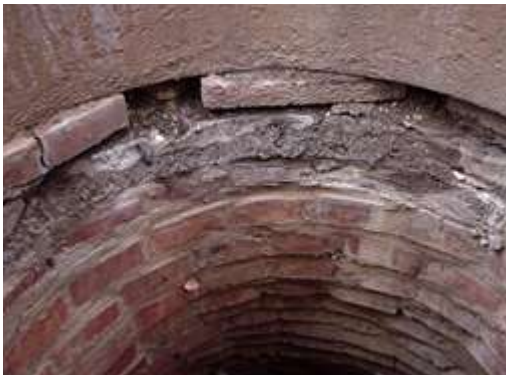
Defect 1

☒ **Cracked**

☒ **Loose Brick**

Loose Bricks

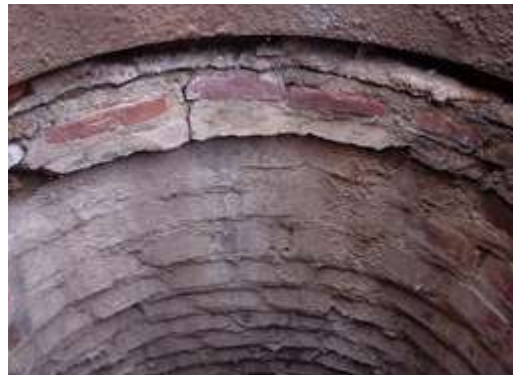
Defect 2

☒ **Leaks**

Frame Leaks

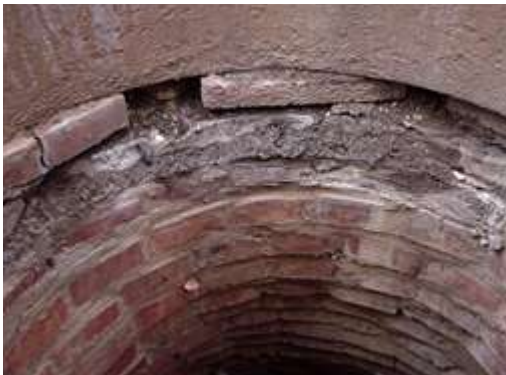
Defect 1

☒ **Cracked**

☒ **Loose Brick**

Loose Bricks

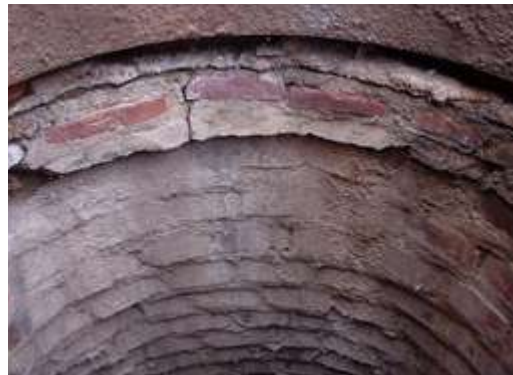
Defect 2

☒ **Leaks**

Frame Leaks
